## Lessons Learned from Waldo Canyon

FIRE ADAPTED COMMUNITIES  
MITIGATION ASSESSMENT TEAM FINDINGS

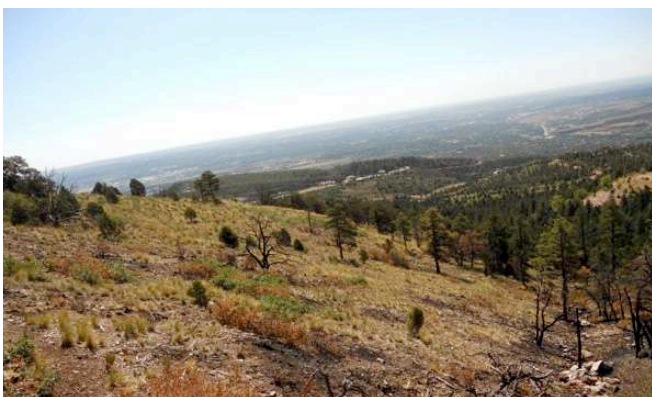
*Figure 1: Solitude Park parcel dominated by Gambel oak, where the results of the fuel treatment by breaking up a continuous layer of shrubby fuels, are still obvious. The Waldo Canyon Fire spread to this treated area. It was extinguished before it spread to homes. Source: USDA Forest Service.*

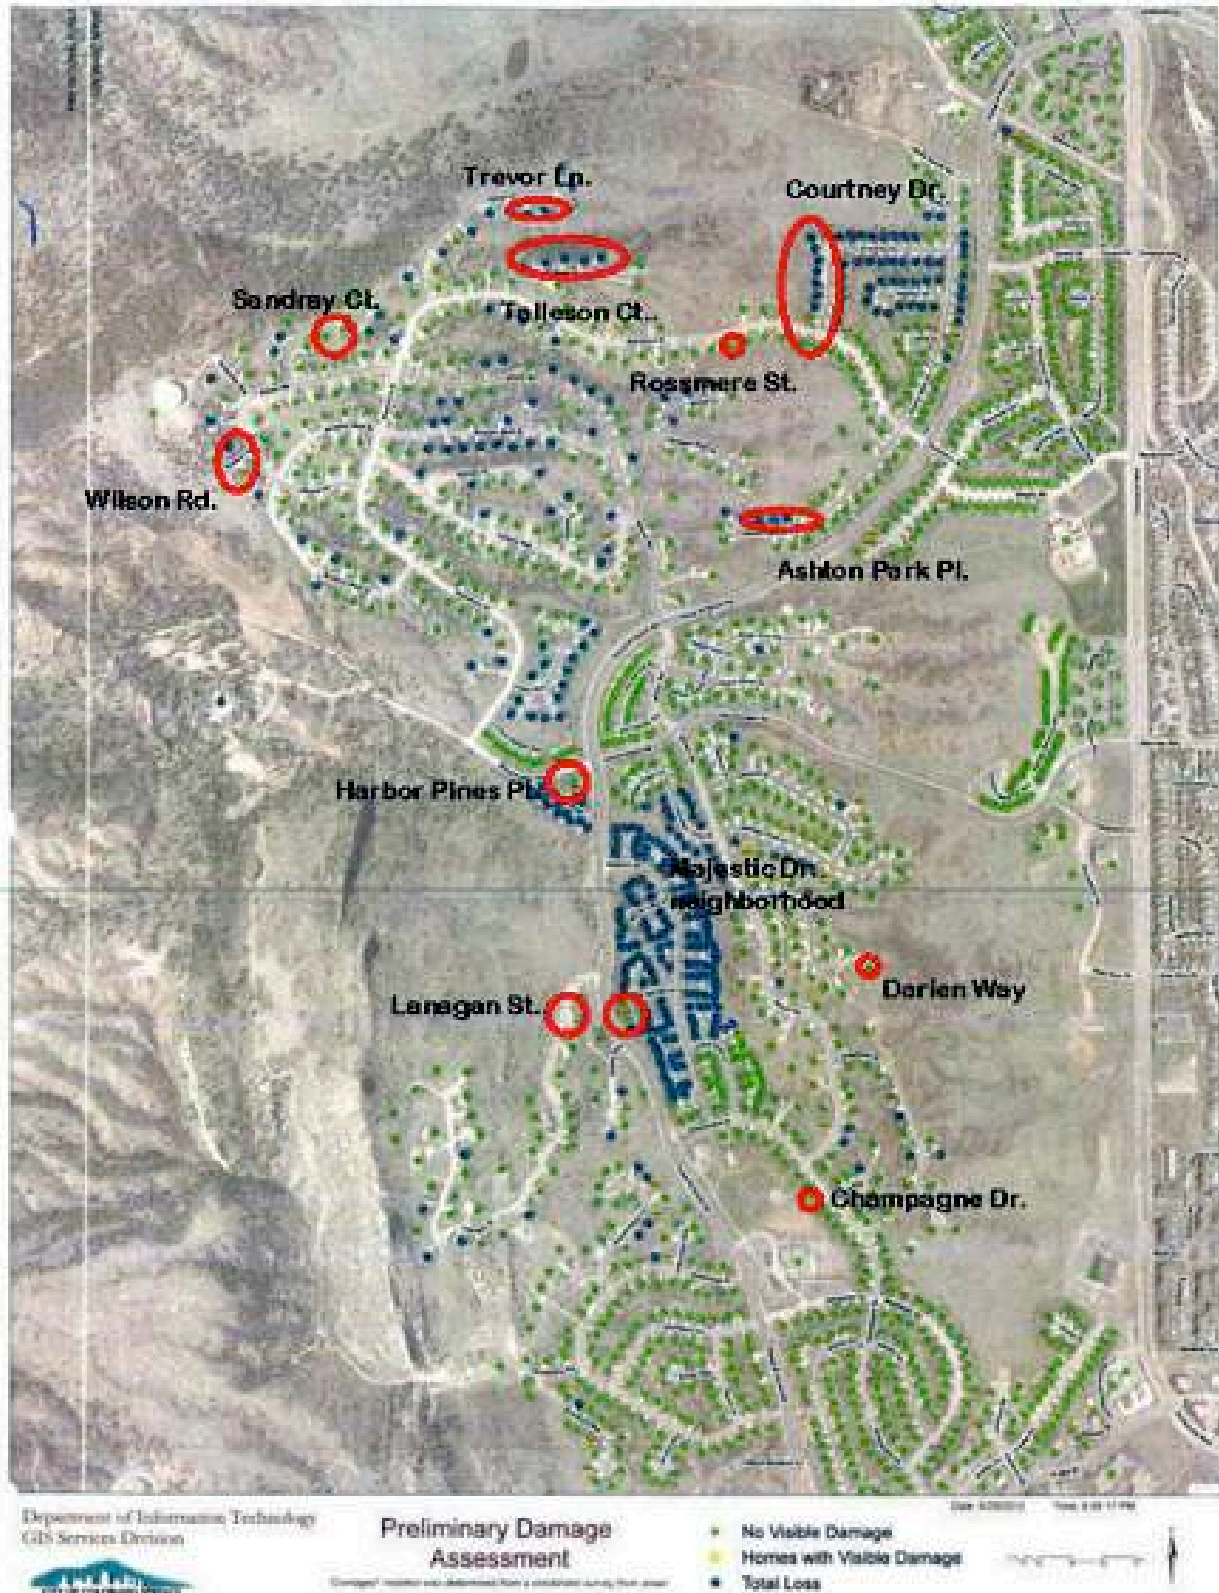
Figure 3: The red circles indicate areas in the Mountain Shadows neighborhood where home assessments were conducted. Source: Colorado Springs Division of the Fire Marshal and IBHS.

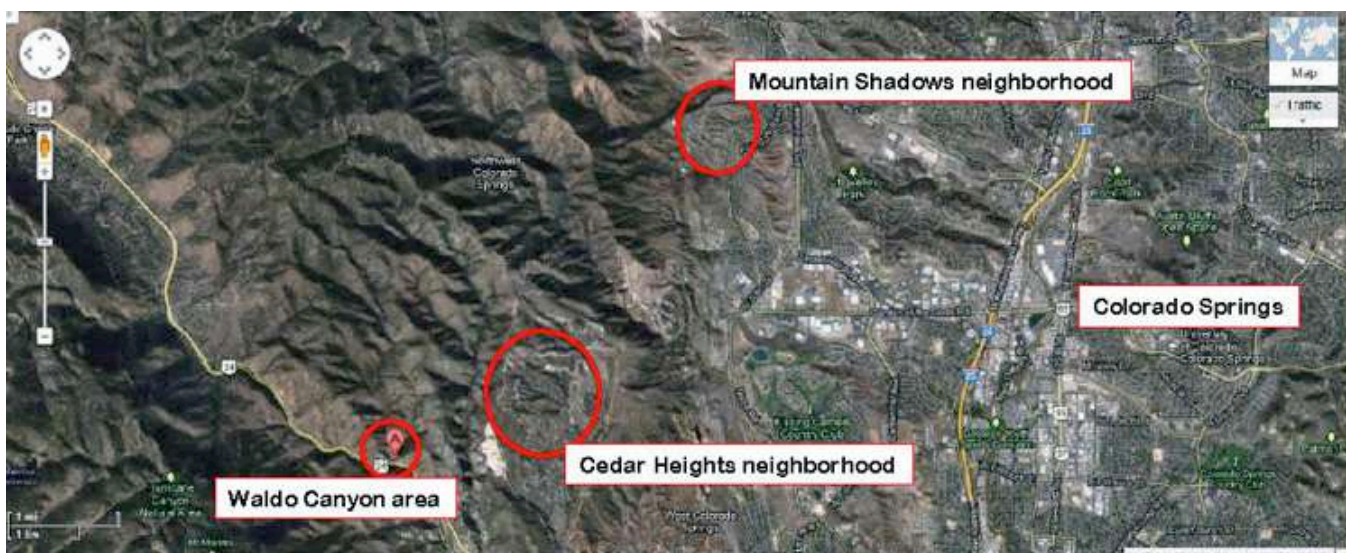
Figure 4: Relative locations of the Cedar Heights and Mountain Shadows neighborhoods in Colorado Springs. Source: Google Maps.

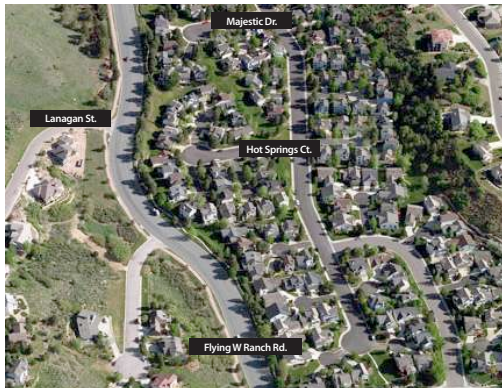
Figure 8: Majestic Drive area of the Mountain Shadows neighborhood prior to the Waldo Canyon Fire. Source: Google Maps.

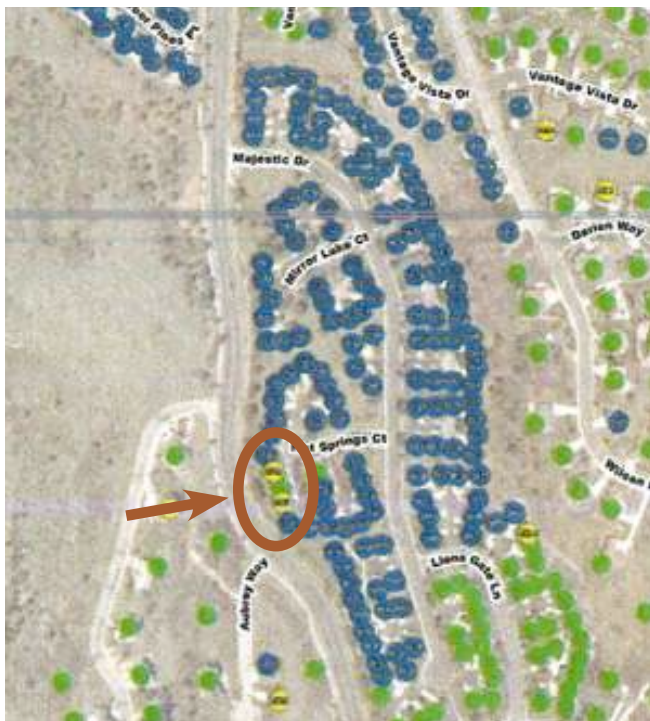
Figure 10: Majestic Drive area of the Mountain Shadows neighborhood showing destroyed (blue), damaged (yellow) and undamaged (green) homes, as shown in the preliminary damage assessment survey map. An undamaged home in the middle identified by an arrow was not included in this field assessment. Source: Colorado Springs Division of the Fire Marshal.

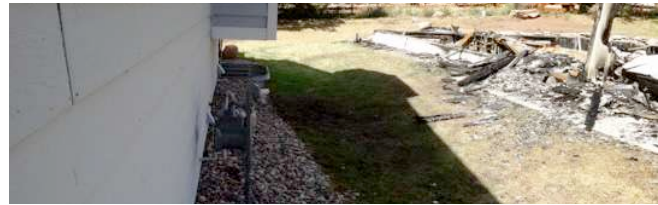
Figure 11: The distance between the destroyed home on the left and the damaged home on the right was approximately 16 feet. Source: IBHS.

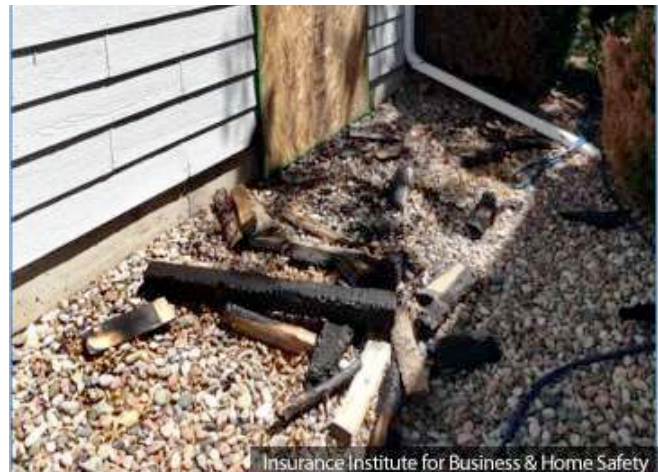
Figure 12: Embers ignited a firewood pile located next to the garage of this home. The direct flame contact exposure from the burning firewood ignited the composite wood (hardboard) siding product. Source: IBHS.

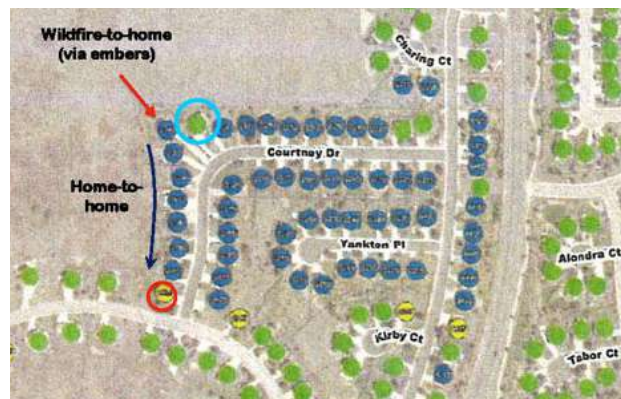
Figure 14: Homes on Courtney Drive that were destroyed by home-to-home spread after an initial wildfire-to-home ignition (indicated with red arrow). One home at the top of slope (red circled) suffered minor damage. The home to the east (right) of the wildfire-to-home, shown as a non-damaged green dot in this figure (blue circled), also had minor damage. Source: IBHS.

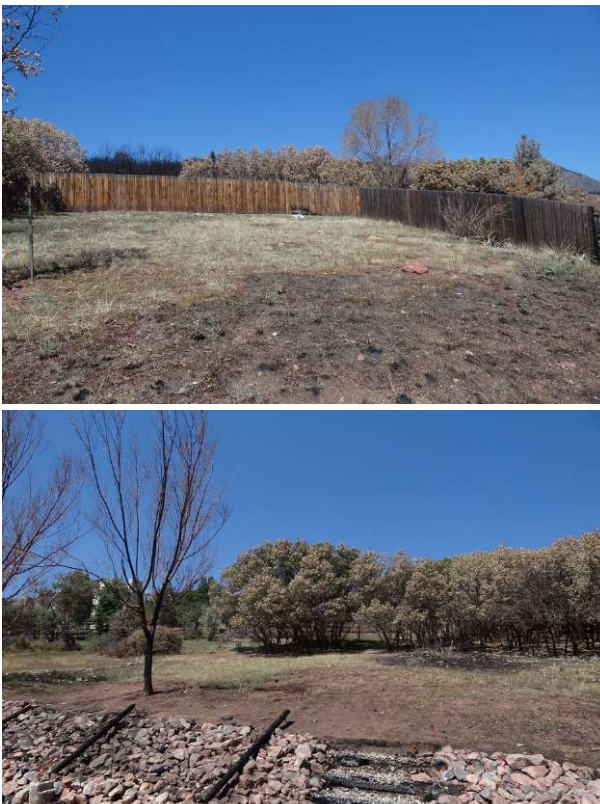
Figure 16: Composite figure of backyards of two destroyed homes on Courtney Drive; photos taken from the home site location. Damage to vegetation and other combustible components was from burning home, not wildfire. Source: IBHS.

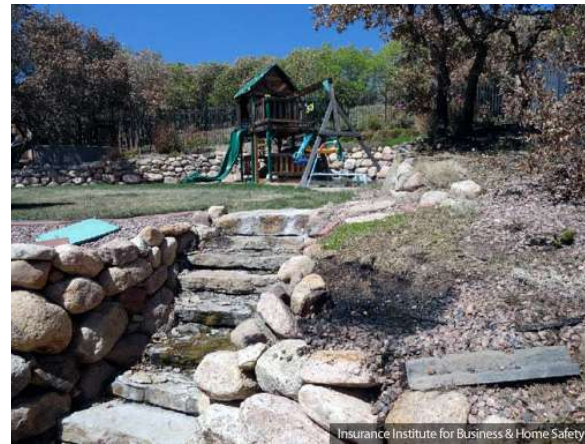
Figure 17: Damage to the play structure slide resulting from radiant heat exposure from the burning Courtney Drive home. Deformation of plastic components (slide and roof) was observed. Scorch or charring of wood structural support members was not observed. Source: IBHS.

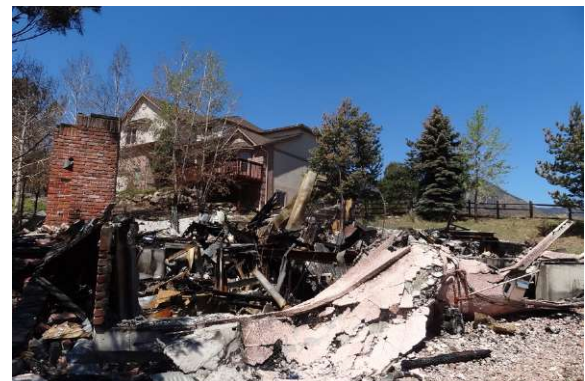
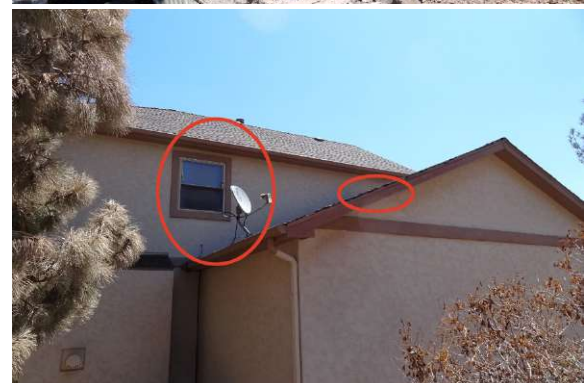
Figure 18: A composite figure of two damaged homes on the west side of Courtney Dr. The up-slope home is above and the down-slope home is below. The charred combustible siding in the up-slope home is not visible in this figure. The damaged components in the down-slope home are circled. Source: IBHS.

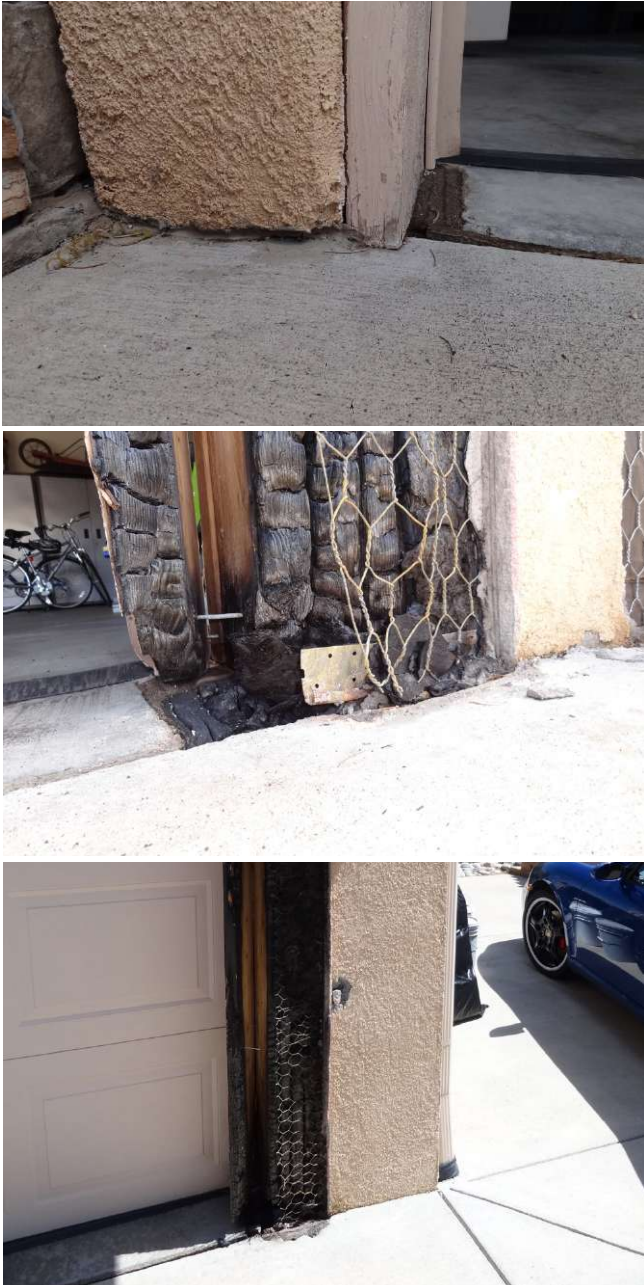
Figure 19: Photographs of the left, middle and right side columns of the two-car garage at a home on Lanagan Street. Note the low clearance between the concrete driveway and the EIFS system, as shown in the left-hand side column. The metal weep screed is visible at the base of the middle column. Source: IBHS.

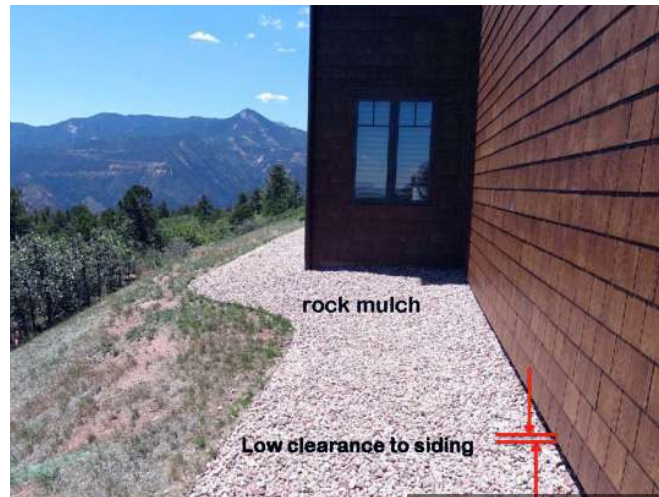
*Figure 22: The back side of the home on Outer Vista Point Road. Noncombustible rock mulch and fiber-cement shingle siding products were used. The low clearance may allow for the underlying wood-based sheathing product to be vulnerable to ember accumulation at the base of the wall. Source: IBHS.*

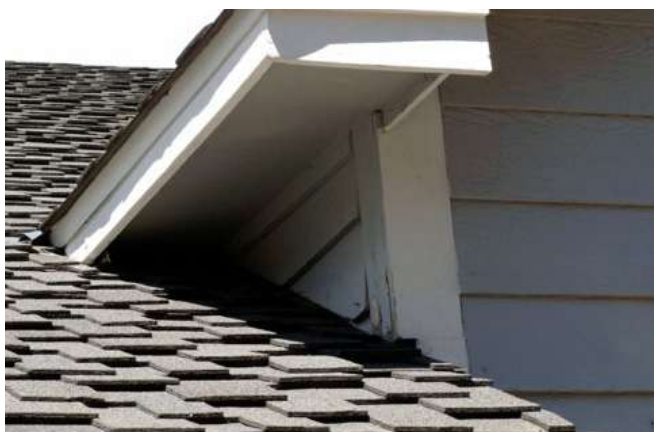
Figure 23: The roof-to-siding return on this complex roof consists of a composite wood (hardboard) siding product and a Class A fire-rated asphalt composition shingle roof covering. Even without vegetative debris at the roof-to-wall intersection, an accumulation of embers could result in ignition of the wood-based siding. Source: IBHS.

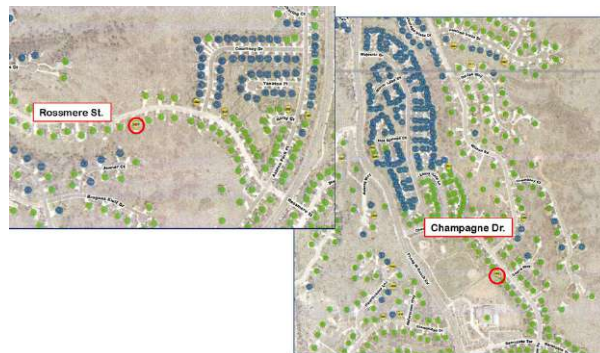
Figure 24: Location of the Rossmere Street and Champagne Drive homes (circled red) within the Mountain Shadows community. Source: IBHS.

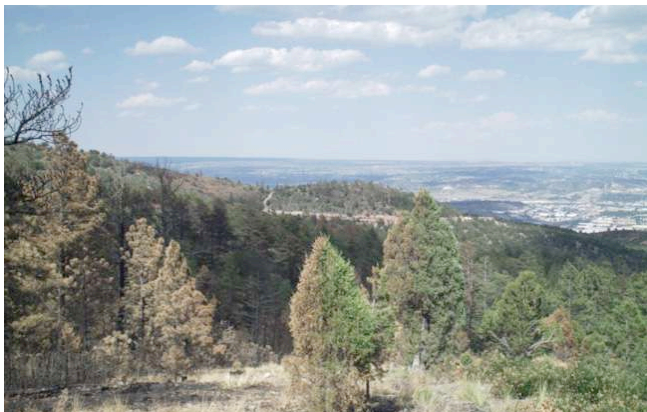
Figure C1: Crown Fire (left), treated Gambel oak (right). Source: NFPA.

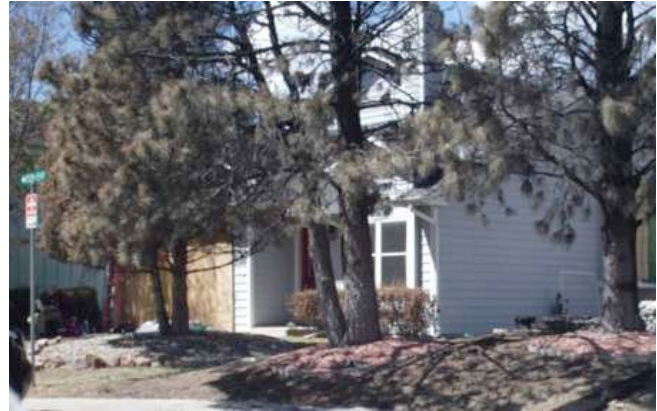
Figure C6: Torched Austrian pine in front of scorched deciduous shrubs below window. Source: NFPA.

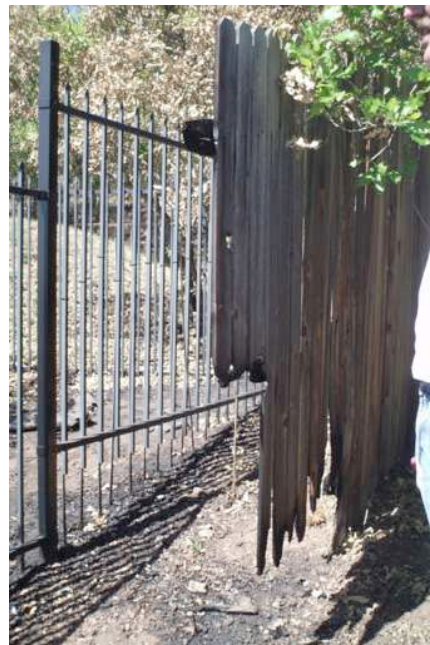
Figure C7: A partially burned cedar privacy fence. Source: NFPA.

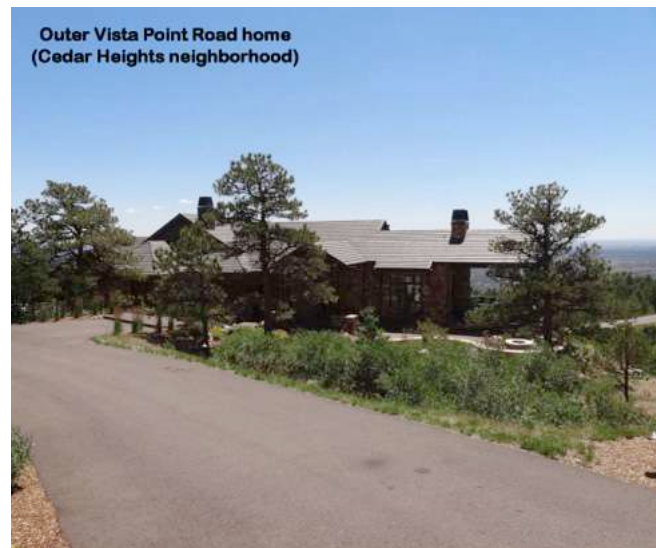
Figure D2: The Outer Vista Point Road, located at the top of the Cedar Heights community. Source: IBHS.

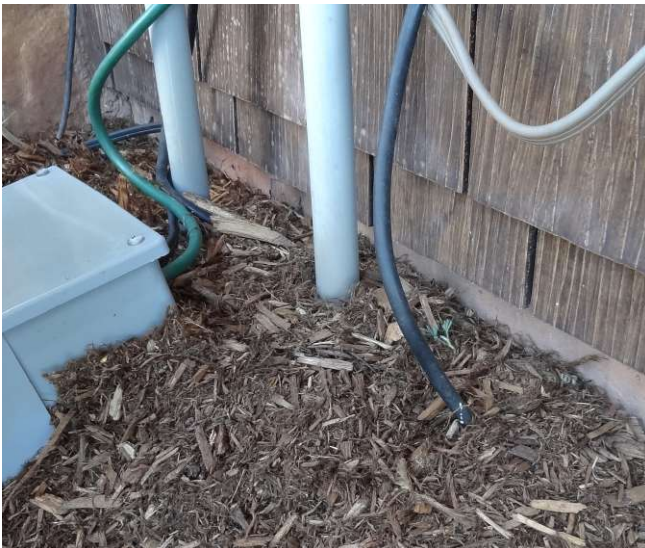
*Figure D6: The upper photograph depicts the vegetation management (defensible space) in the 0-to-5 foot zone on the right side of the house. The lower photograph shows low earth-to-siding clearance. Source: IBHS.*

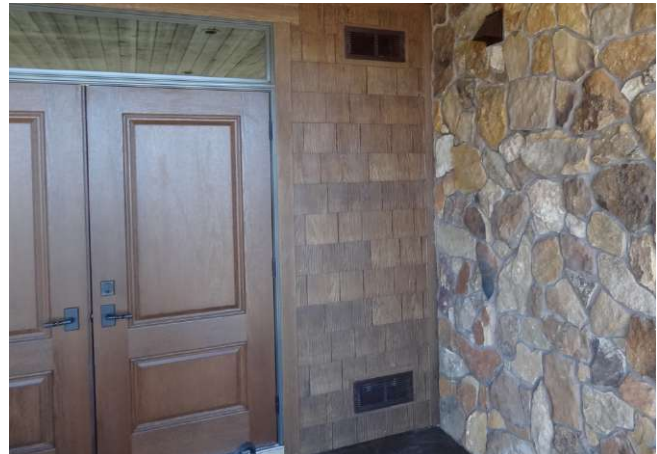
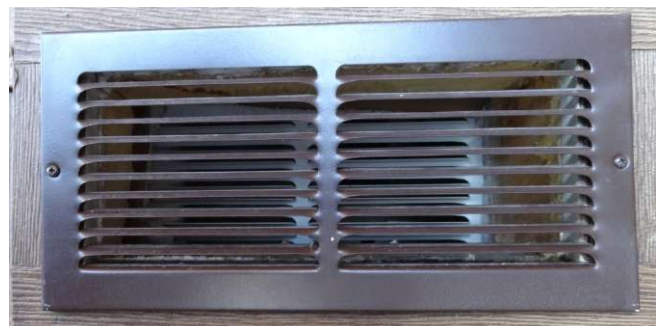
*Figure D7: These photographs show venting for the make-up air to a room containing gas appliances. Metal screening was missing from these vents, as seen in the lower photograph. Source: IBHS.*

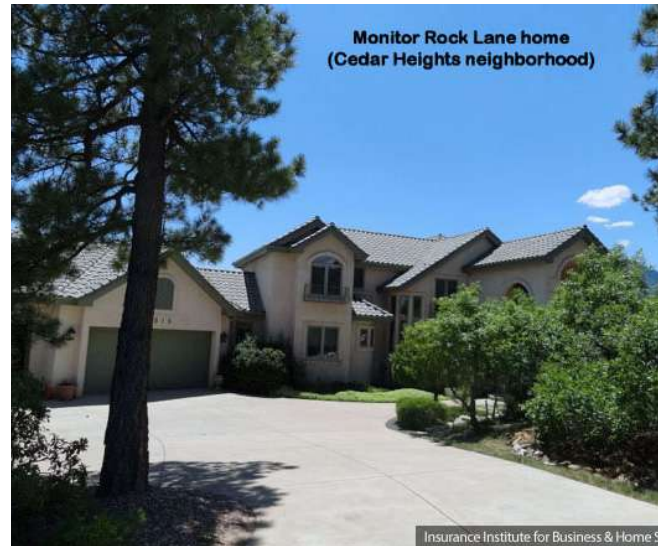
Figure D9: The Monitor Rock Lane home located in the Cedar Heights neighborhood. Source: IBHS.

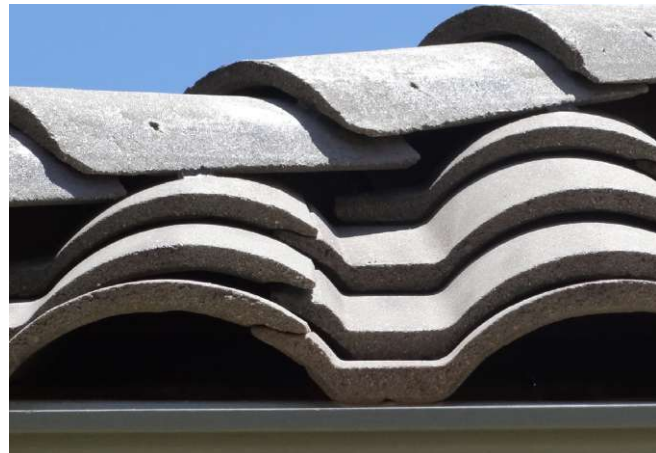
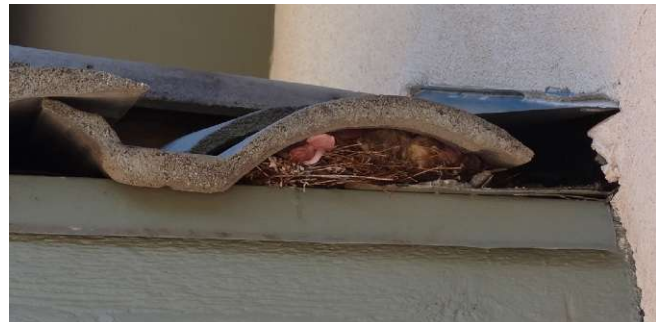
*Figure D17: The ends of the barrel-tile roof covering on this home were not “bird-stopped.” Note the debris in the under-roof area at the end of the roof (lower photograph). Source: IBHS.*

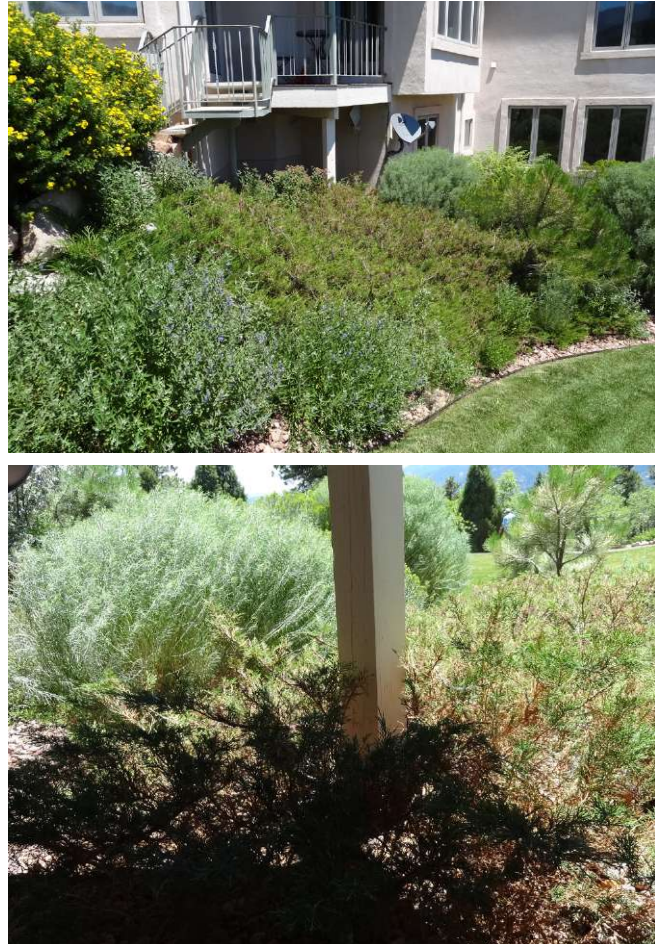
*Figure D18: These photographs show the solid surface deck (upper) and the near-home vegetation under and near the deck (lower). The lower photograph was taken while under the deck. Source: IBHS.*

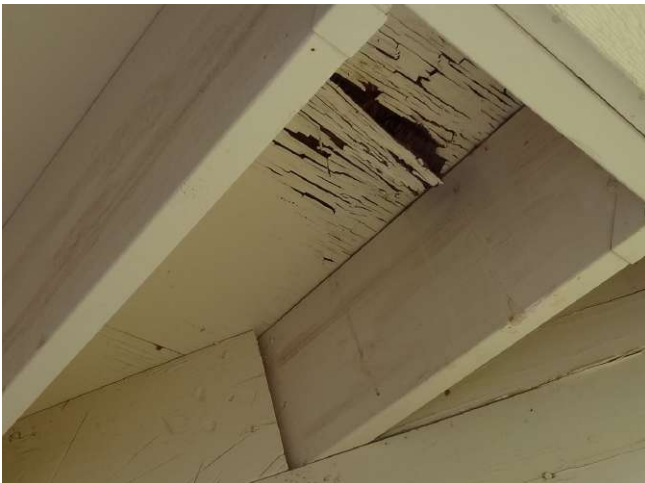
*Figure D19: The flagstone covering on this solid surface (noncombustible) deck had failed (upper) allowing water to get below the covering, eventually resulting in fungal decay in the horizontal wood-based sheathing (lower). Source: IBHS.*

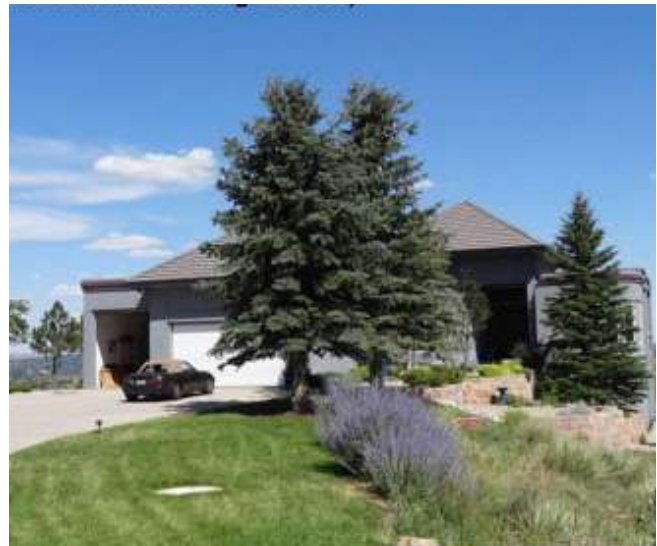
*Figure D20: The Darien Way home, located in the Mountain Shadows neighborhood. Source: IBHS.*

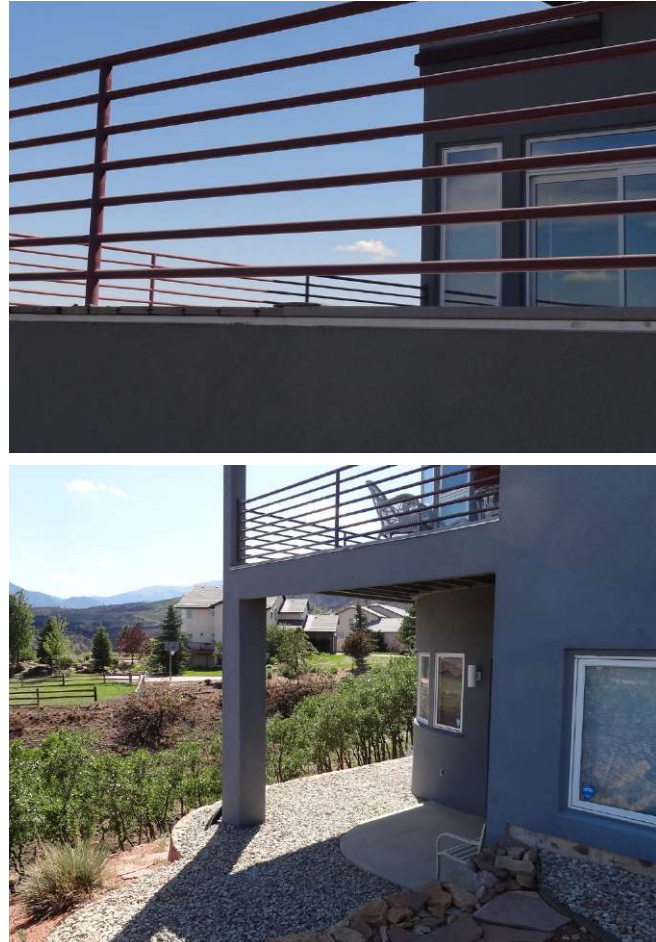
*Figure D23: The decks at this home used wood for the structural support system and a combustible wood-plastic composite decking (walking surface) product. Source: IBHS.*
